### VER PLOEG ESTATES PLANNED UNIT DEVELOPMENT DESIGNATION

# Wetland Disturbance and Mitigation Plan

#### **EXHIBIT D**

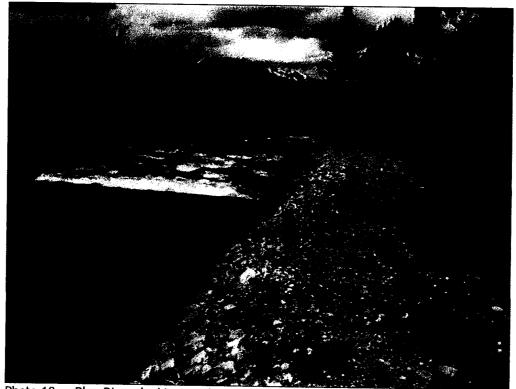
Photo 10 — Blue River; looking northwest

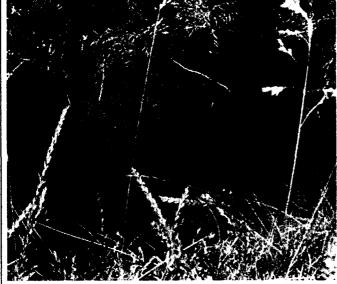
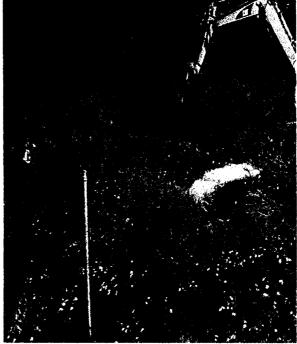
### TEST PIT NO. TP2

Sity and clayey sand, more sandy than above with some cobbles and boulders, medulim brown, moist, sub angular to sub rounded, compact, medium to coarse sand.

Clean sand with few fines, SW, decomposed bedrock, light brown, wet, angular to sub angular, compact, coarse grained with gravel, cobble and small boulders. Practical refusal at 5 ft. Appears to be in-place, weathered igneous bedrock.
